US Army Corps  
of Engineers  
Construction Engineering  
Research Laboratories

Technical Report REMR-OM-16  
September 1995

# REMR Management Systems—Navigation and Reservoir Structures, Condition Rating Procedures for Concrete in Gravity Dams, Retaining Walls, and Spillways

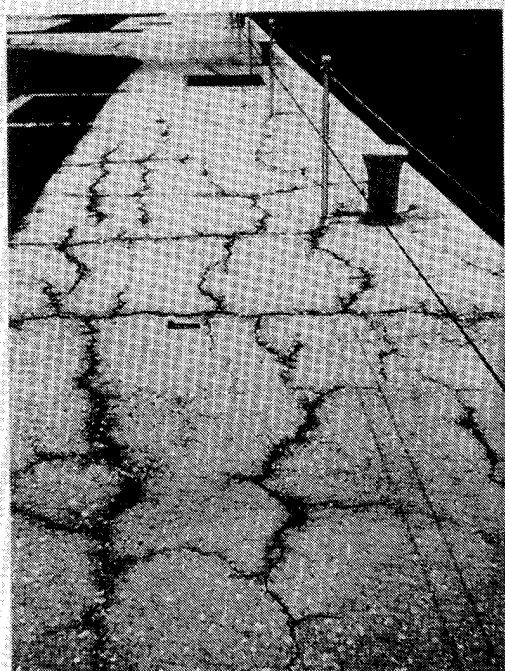
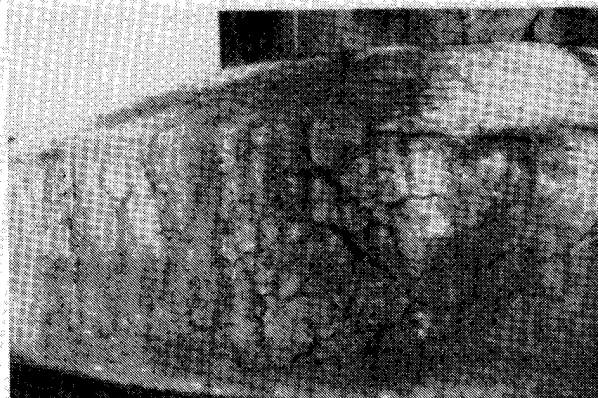
Fig. A.1.6a—Pattern cracking (fine)

Fig. A.1.6b—Pattern cracking (medium)

Fig. A.1.6c—Pattern cracking (wide)

Fig. A.1.6e—Pattern cracking (restraint of volume change)

Fig. A.1.6d—Pattern cracking (alkali-silica reaction)

Fig. A.1.6f—Pattern cracking (alkali-carbonate reaction)

**Pattern cracking (category 23).** Pattern cracking results from a relative volume change of interior and exterior concrete. Pattern cracking together with distortion generally indicates a volume increase such as occurs from alkali-aggregate reaction. The effect is generally shallow, less than 1 ft. Extensive pattern cracking makes coring advisable to determine depth and cause. Pattern cracking may progress to disintegration. The effect of cycles of freezing and thawing also contributes to further deterioration of concrete with pattern cracking.

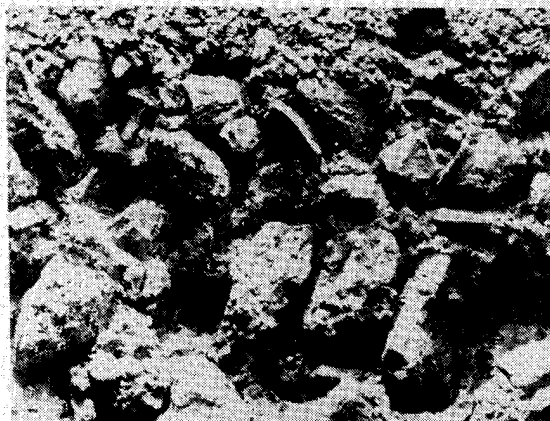
*Fig. A.2.3—Cavitation damage*

**Cavitation (category 32).** Cavitation results from the collapse of vapor bubbles in flowing water and is generally caused by high-velocity flow over abrupt changes in surface alignment. Cavitation causes additional changes in alignment. To prevent further damage, repairs should be made promptly and the cause of the damage should be eliminated. Deduct values from Table 4 are used. Measurement should be at the point of deepest cavitation.

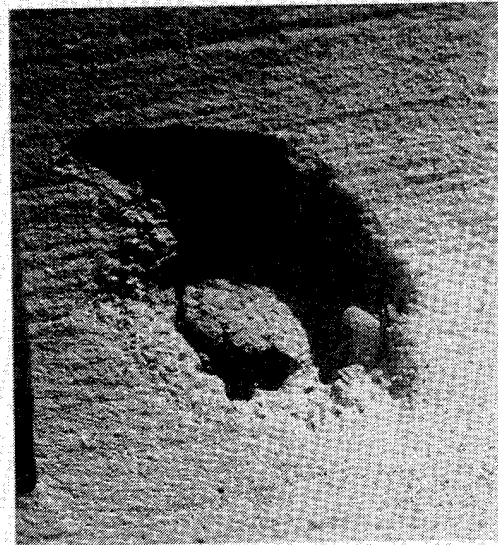
*Fig. A.2.19—Popout*

**Popouts (category 34).** Popouts generally are caused by freezing of saturated porous aggregate particles but may also result from alkali-aggregate reaction. They are more aesthetically offensive than structurally serious.
